# AERIAL PHOTOGRAPHIC ANALYSIS OF GARY DEVELOPMENT LANDFILL

## Gary, Indiana

TS-AMD-85606-8  
September 1985

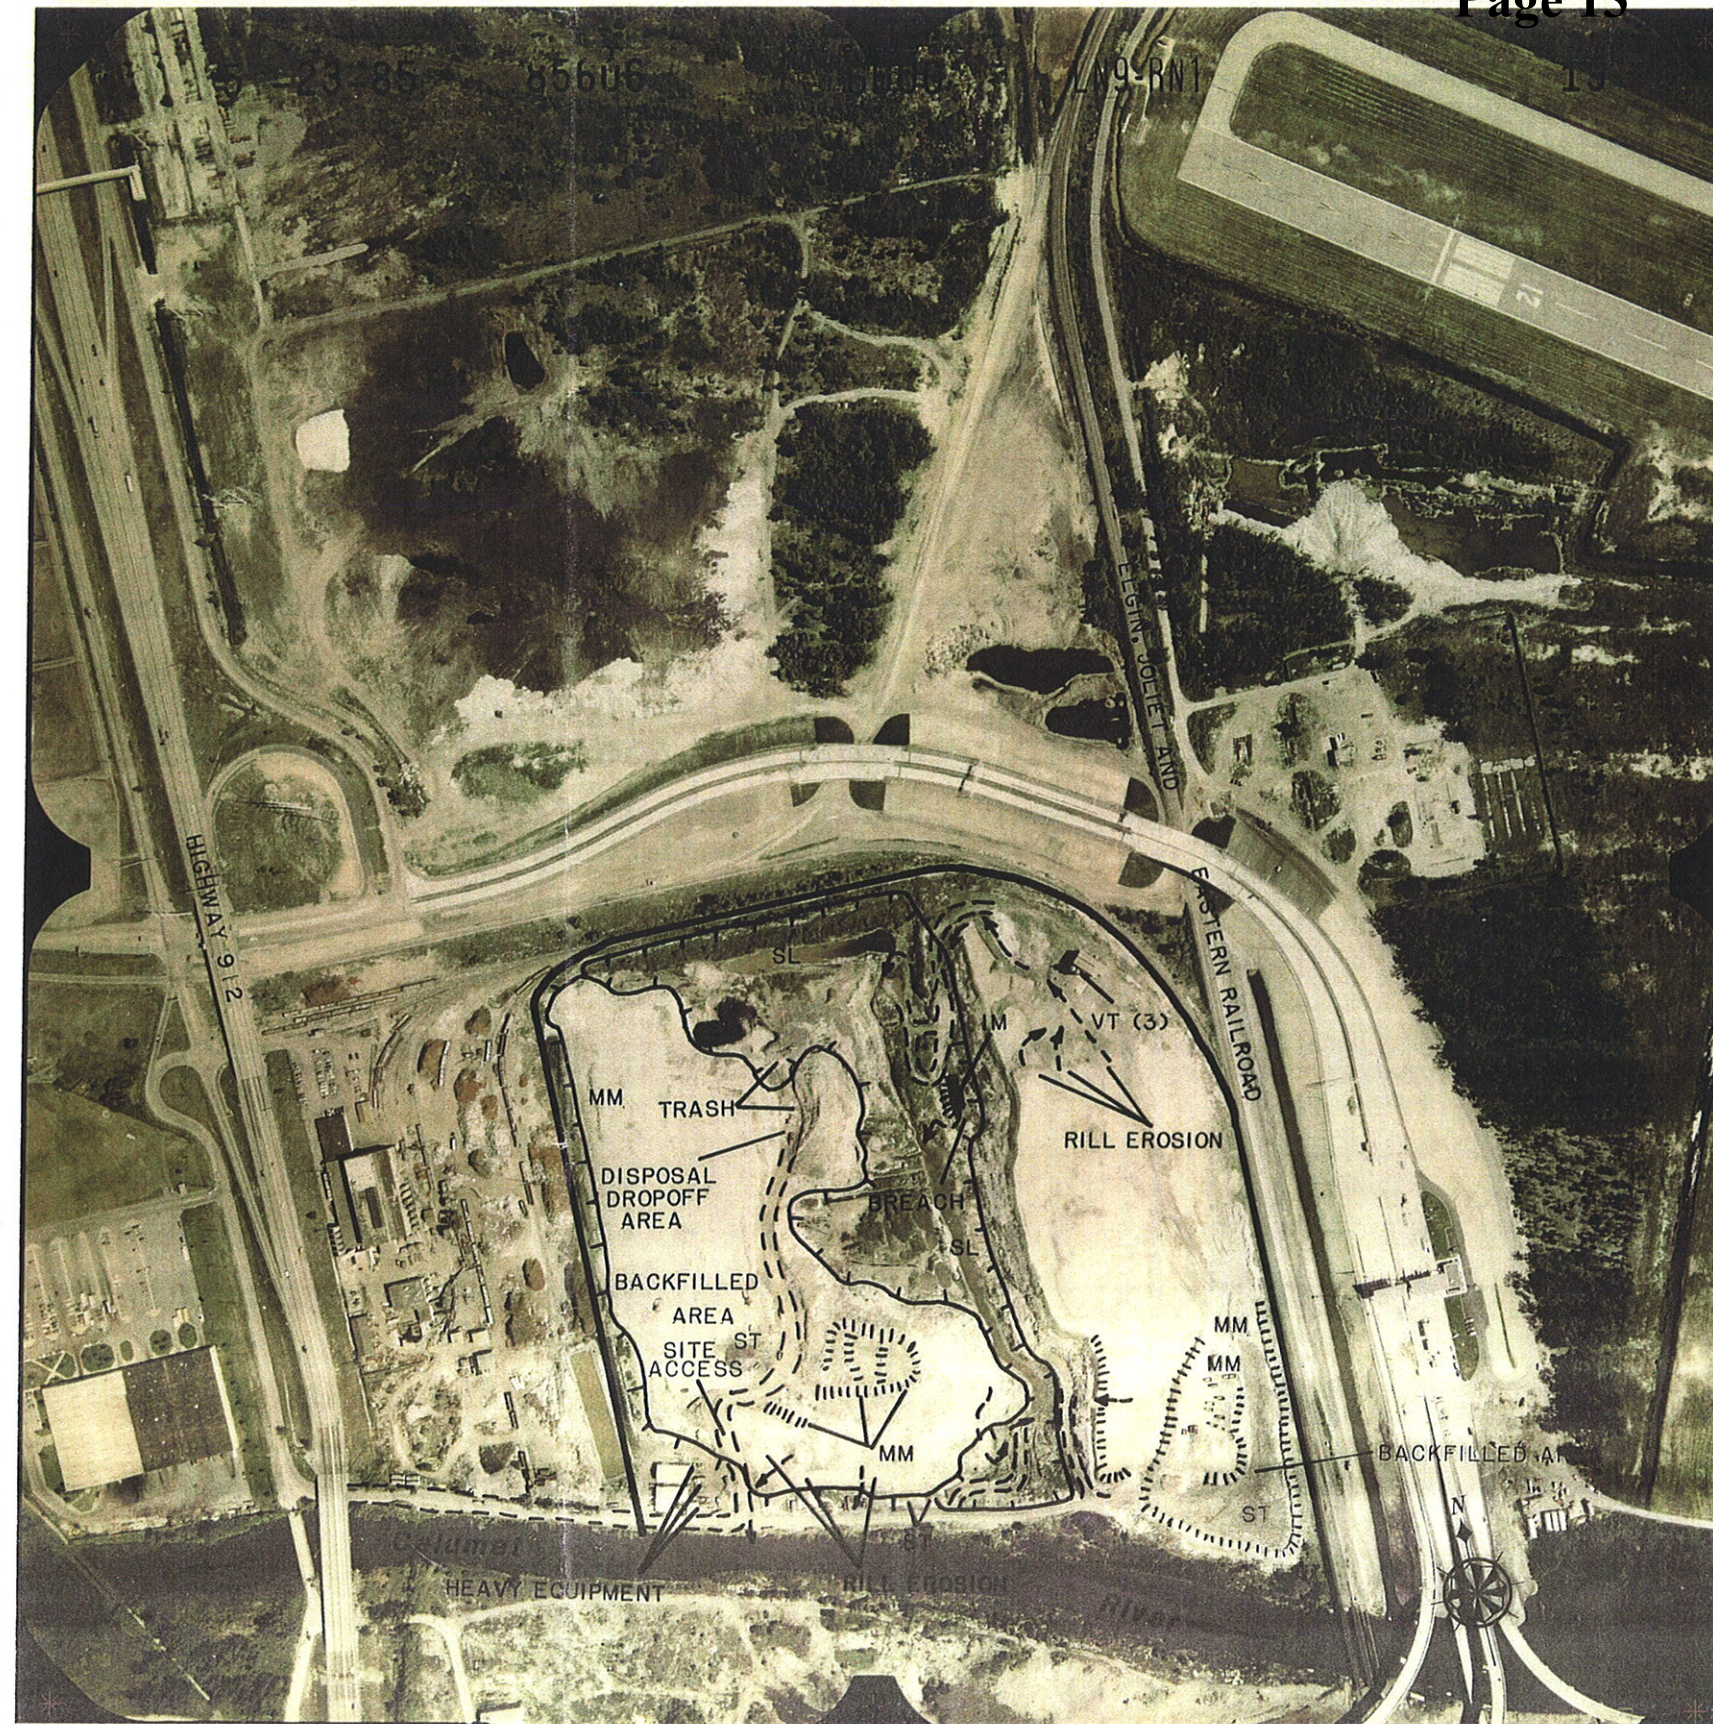
Figure 3. Gary Development Landfill, May 23, 1985. Approximate scale, 1 inch equals 277 feet.

The site appears to be an old gravel pit that is now an active waste disposal facility. Vehicles with trash in them are visible in the disposal dropoff area. Ground stains and rill erosion were present and three vertical tanks were located in the northeast corner of the site.

The Gary Development Landfill appears to be an old gravel pit that is being used for waste disposal. The active part of the landfill is in the pit on the western side of the site. There is a trash collection area at the end of the site access road and trucks are visible along the road. The western portion of the pit has probably been backfilled. The backfilled area extends from the south near the Calumet River to the north portion of the site. Standing liquid is visible at the bottom of the landfill. Heavy equipment is parked in the southwest corner of the site. North of the heavy equipment is a ground stain and some mounded material on the backfill mound. The backfilled area has some rill erosion along its southern side. There is also a ground stain along the southern side of this area. Some rill erosion is also visible in the northeast corner of the site. Runoff follows the erosion and eventually empties into the bottom of the pit. A building and three vertical tanks are north of the rill erosion. In the bottom of the landfill is a small impoundment that has a breach in its containment wall. In the southeast corner of the site is a large ground stain. This stained area may be a backfilled area. Material has been mounded to form berms in this section of the site.
